Manhole Inspection Summary

Manhole # S17YY1016MH

Insp Date: **4/2/07 11:35 AM**

Location Address: **NORTHERN PKWY**

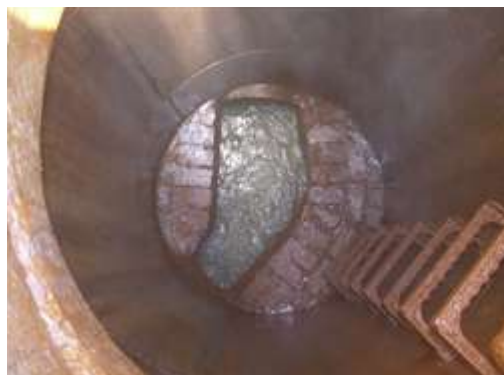
Top View

Frame leaks. Adjustment and Corbel infiltration.

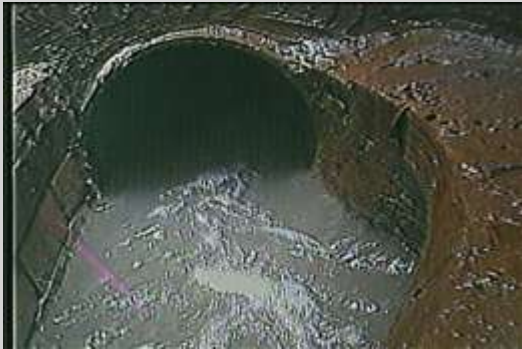
18 in. Circular Gravity Sewer Pipe Out @ 12 O'Clock

Invert Depth: **11.79** (ft.) Flow Characteristics: **Fast**

Infiltration: **None** Pipe Seal Cond: **Unknown**

Connects To: **Stub connection / abandoned**

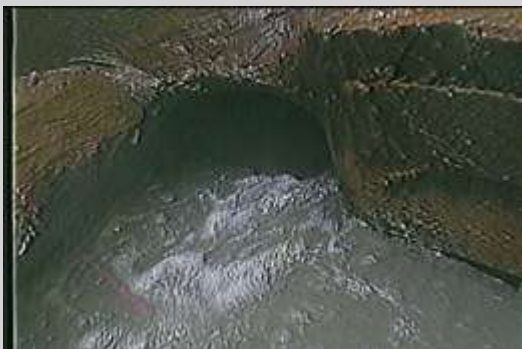
15 in. Circular Gravity Sewer Pipe In @ 7 O'Clock

Invert Depth: **11.70** (ft.) Flow Characteristics: **Fast**

Infiltration: **None** Pipe Seal Cond: **Unknown**

Connects To: **Stub connection / abandoned**
